NATIONAL TRANSPORTATION SAFETY BOARD

CONTROL LOCK STUDY

WPR21FA283

Location: Lewiston, Idaho
Date: July 24, 2021
Aircraft: N28U, SIAI-Marchetti, SM1019B
NTSB Investigator-in-Charge: Andrew Swick

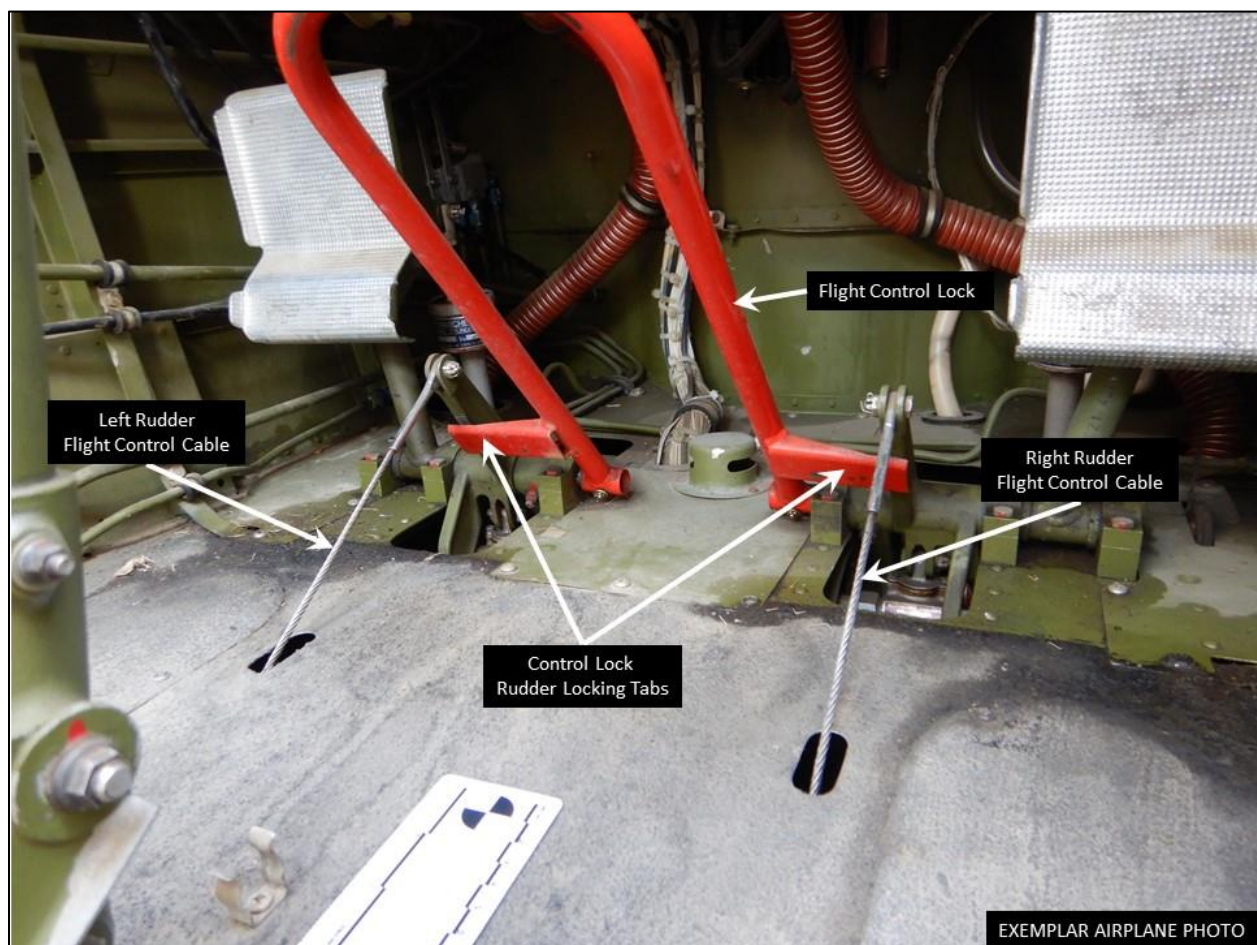
Examination of a similarly equipped SIAI-Marchetti, SM1019 revealed that with the control lock engaged (See figure-1), although the ailerons and elevators were completely locked, the rudder could still be moved to almost full travel, such that the airplane could be maneuvered almost completely unhindered while taxiing (figure 3, 4).

Figure 1-Flight control lock in the up position.

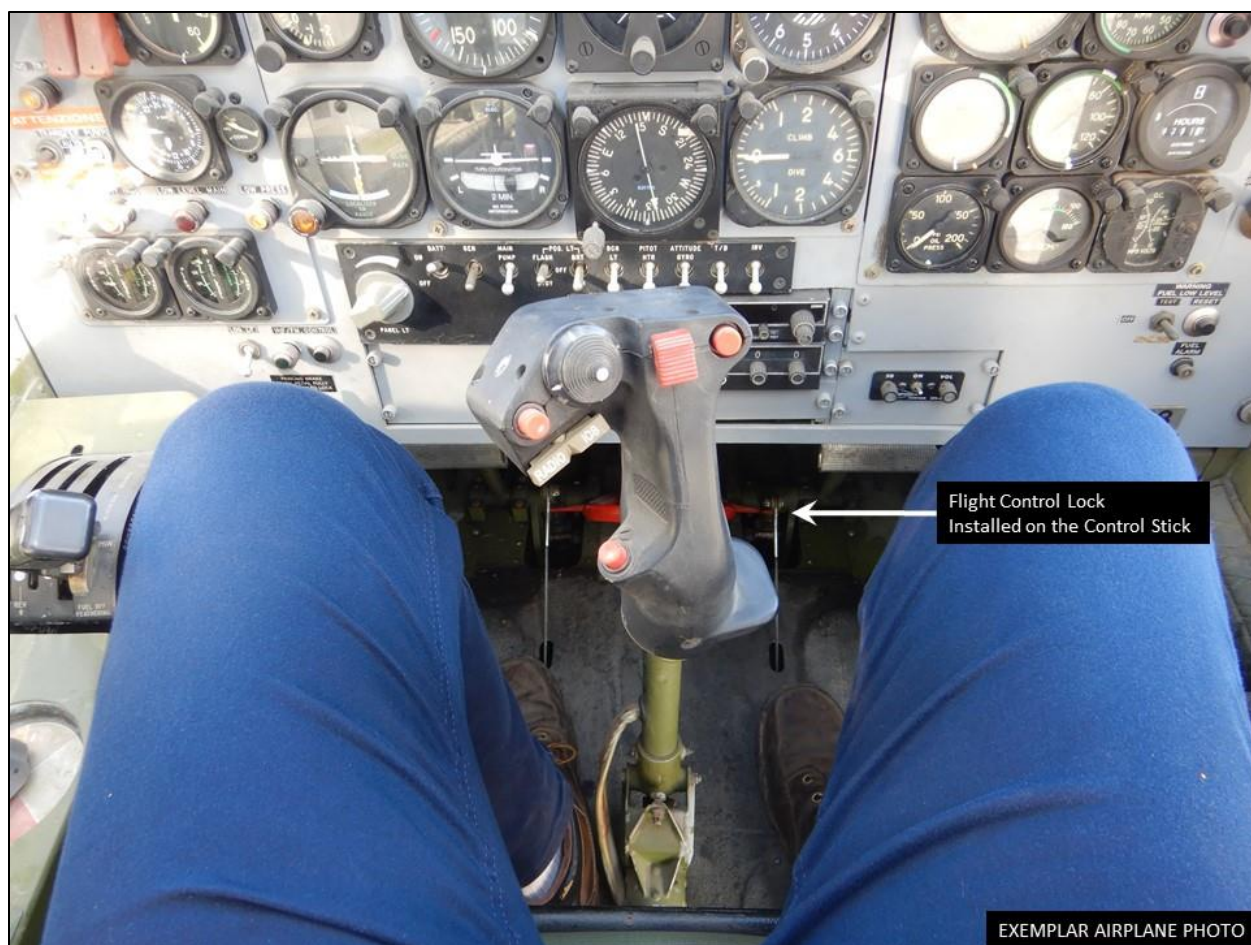
Figure 2-View of the control lock from the pilot's position.

Although the control is painted red, the pilots view of the lock in the engaged position is such that the lock is viewed at its narrowest profile, directly down its length. (Figure 2)

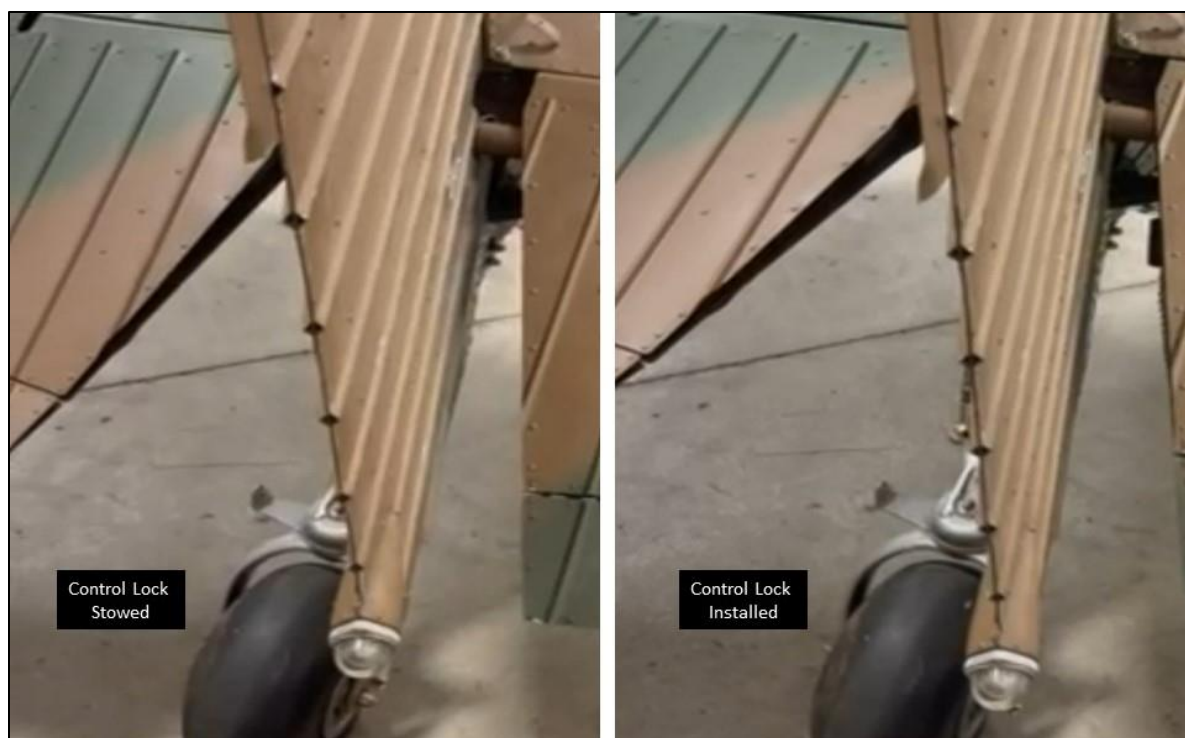
Figure 3-Exemplar airplane, right rudder without the control lock installed and with the control lock installed.

The airplane did not have the tail wheel chains connected for this test.

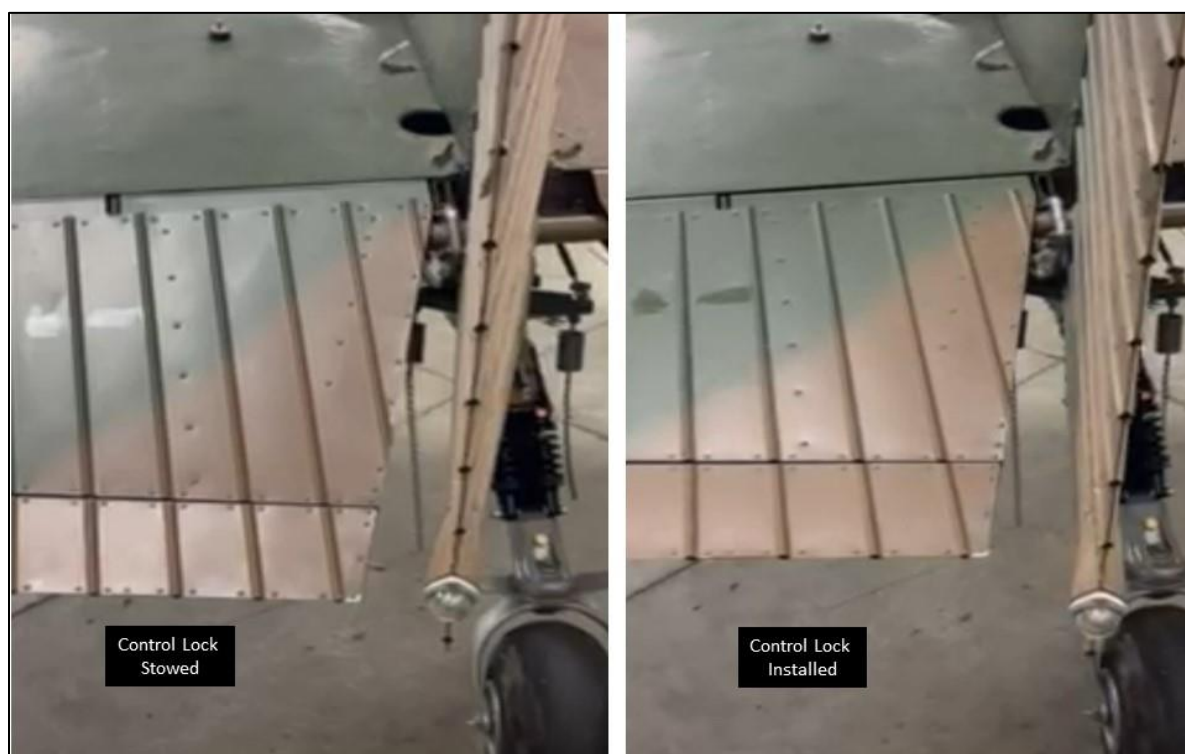
Figure 4-Exemplar airplane, left rudder without the control lock installed and with the control lock installed.
